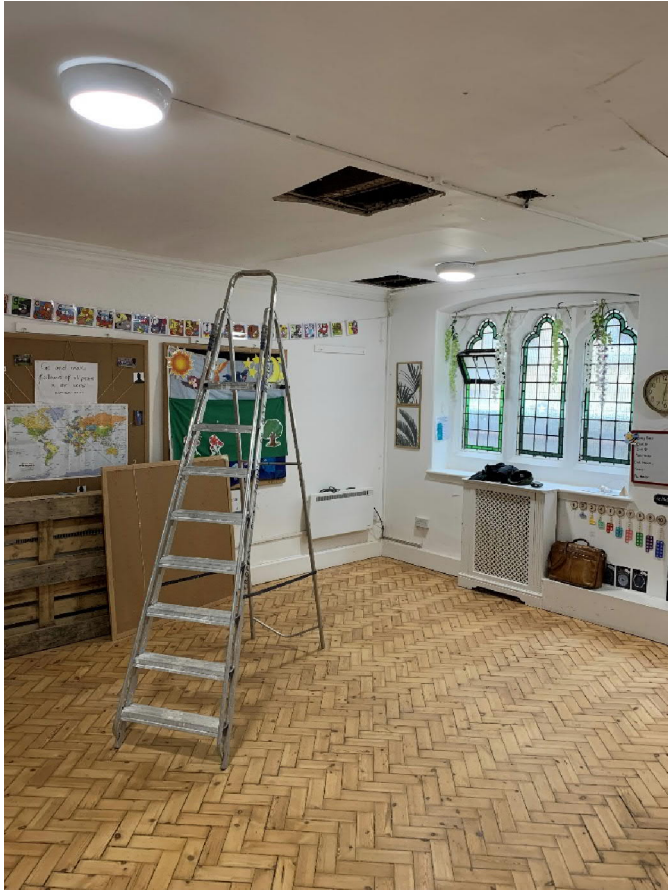
Figure 3 – Vestry showing access opening-up holes.

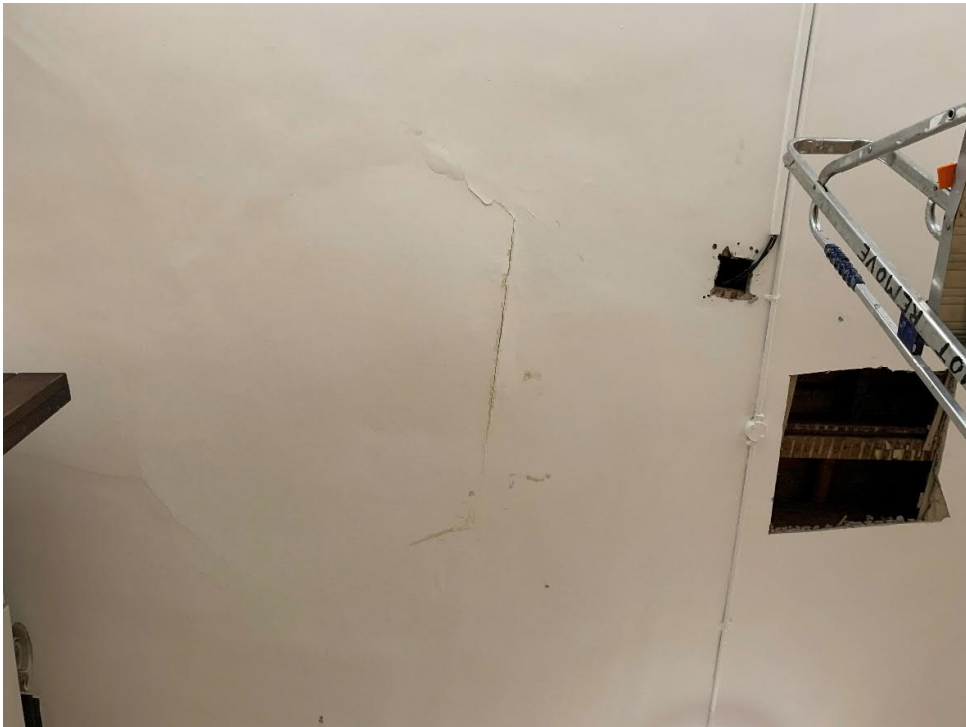
Figure 4 – Vestry Ceiling showing crack and bulge.

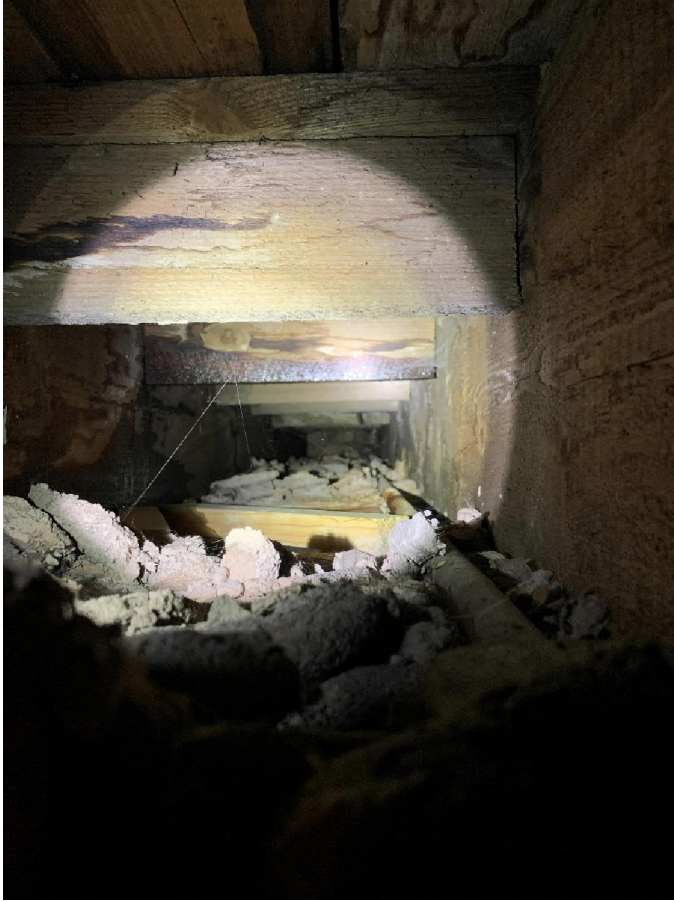
*Figure 5 – Roof void below drip showing wet area at bottom of noggin and new timbers supporting a recent ceiling repair.*

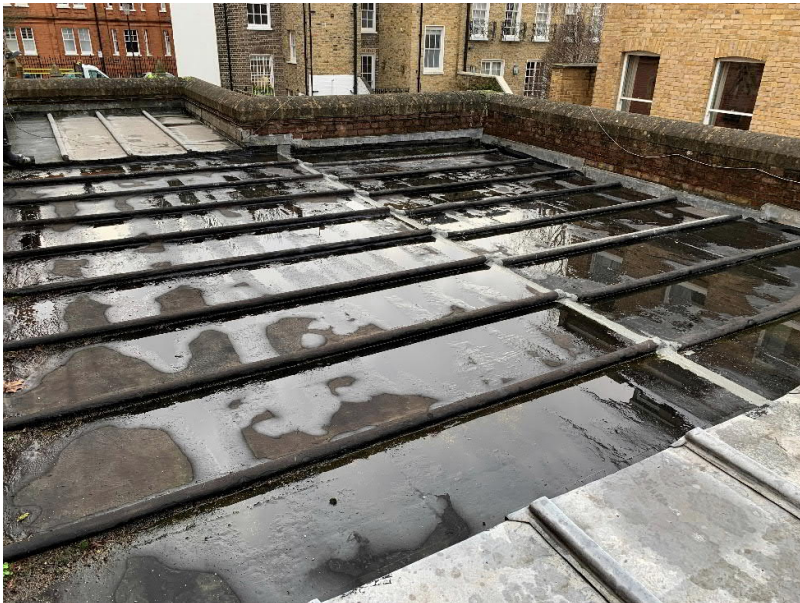
*Figure 6 – Vestry Roof Covering. Central section covered in bitumen. The roof pitch is very shallow and there was a lot of standing water.*

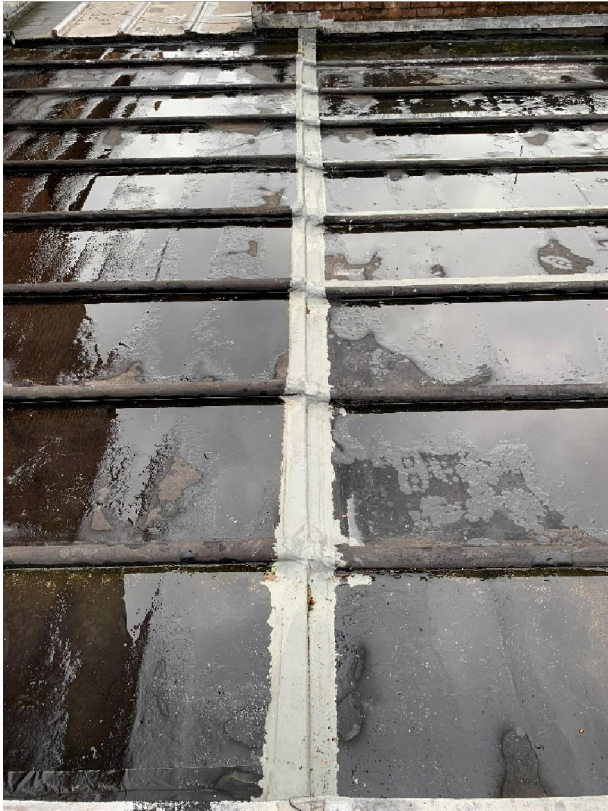
Figure 7 – Showing drip with Westwood PMMA waterproofing system applied in November 2023.

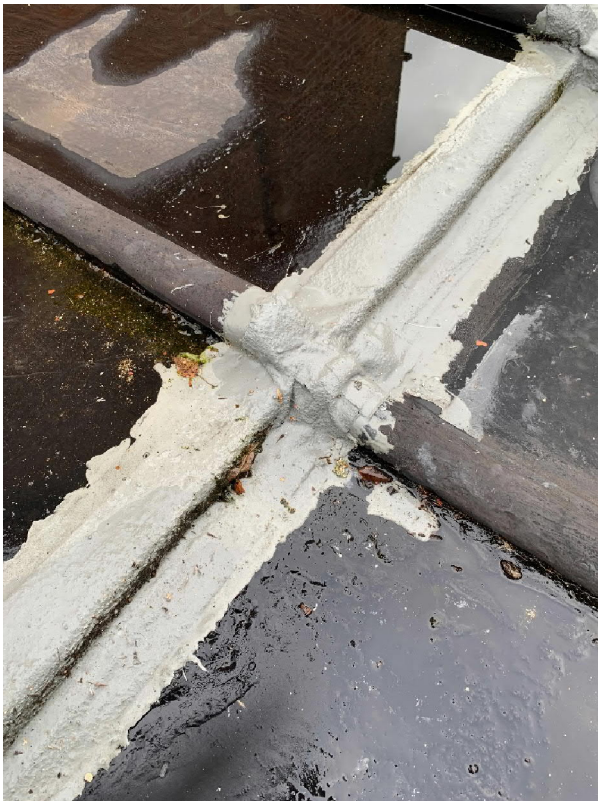
Figure 8 – Detail of above.

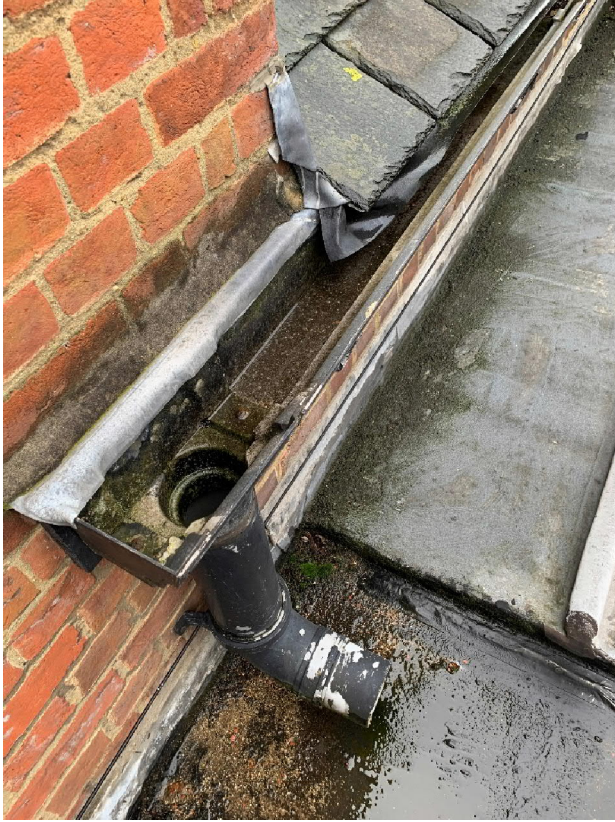
*Figure 9 – North Aisle gutter discharging onto vestry roof.*
